## TREE ASSESSMENT REPORT

Applicant: **Body Coprorate for St James CTS 19922**  
Respondent: **Jennifer Lynn Nicol  
Brisbane City Council**  
Case number: **NDR207-23**  
Site address: **47A Tristania Road  
CHAPEL HILL QLD 4069**

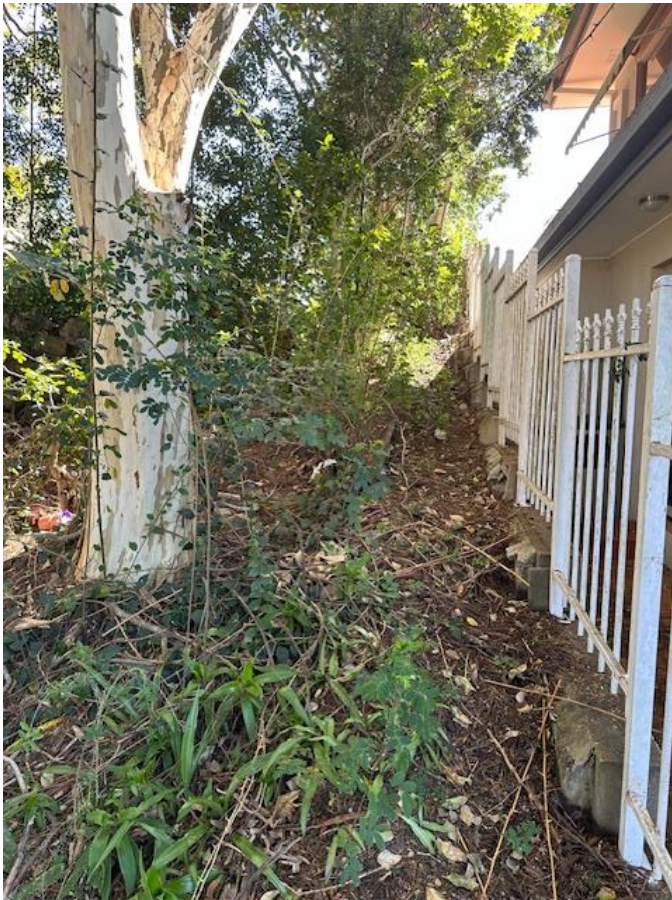
Tree No. 1 basal region

Tree No. 1 is a mature Leopardwood. The subject tree is wholly located within the respondent's property and is positioned approximately 2 metres from the dividing fence.

The subject tree extends across the boundary by approximately 4 metres.

Pruning to the boundary will remove the majority of the upper crown and be in breach of Australian pruning standards.

It is recommended that Tree No. 1 be removed in its entirety due to a lack of options to effectively mitigate by pruning.

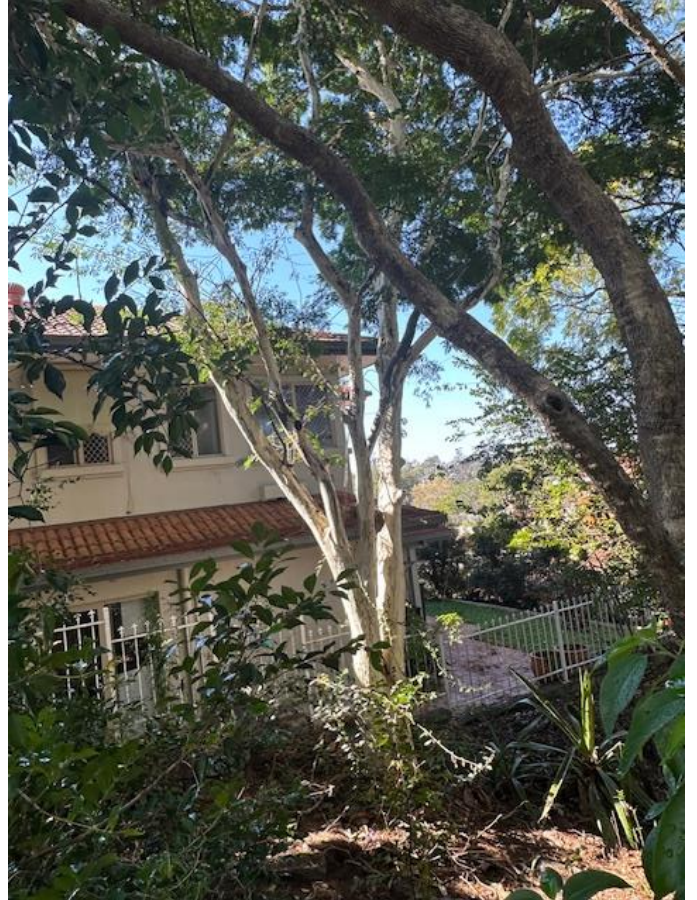
Tree No. 1 as seen from respondents

The subject tree is phototropic and growing toward the east from beneath the canopy of another tree set adjacent to the West.

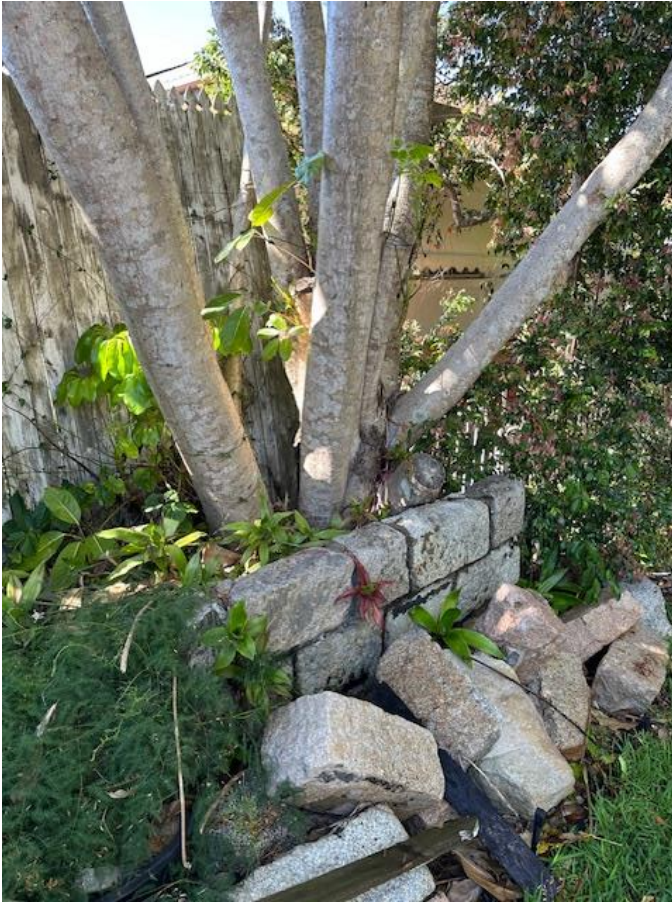
Tree No. 2 basal region

Tree No. 2 is a mature Umbrella. It is wholly located within the respondent's property and positioned approximately .5m from the dividing fence.

It is recommended that Tree No. 2 be removed in its entirety due to its status as a weed.

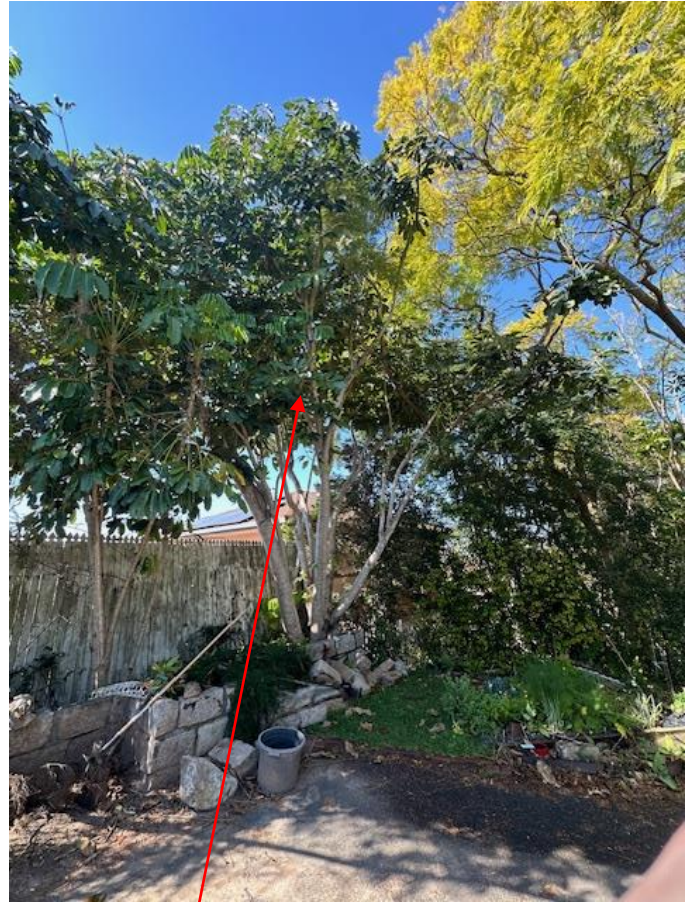
Tree No. 2 as seen from respondents

The subject tree is native to northern Qld, however, is considered a category 3 weed in southeast QLD.

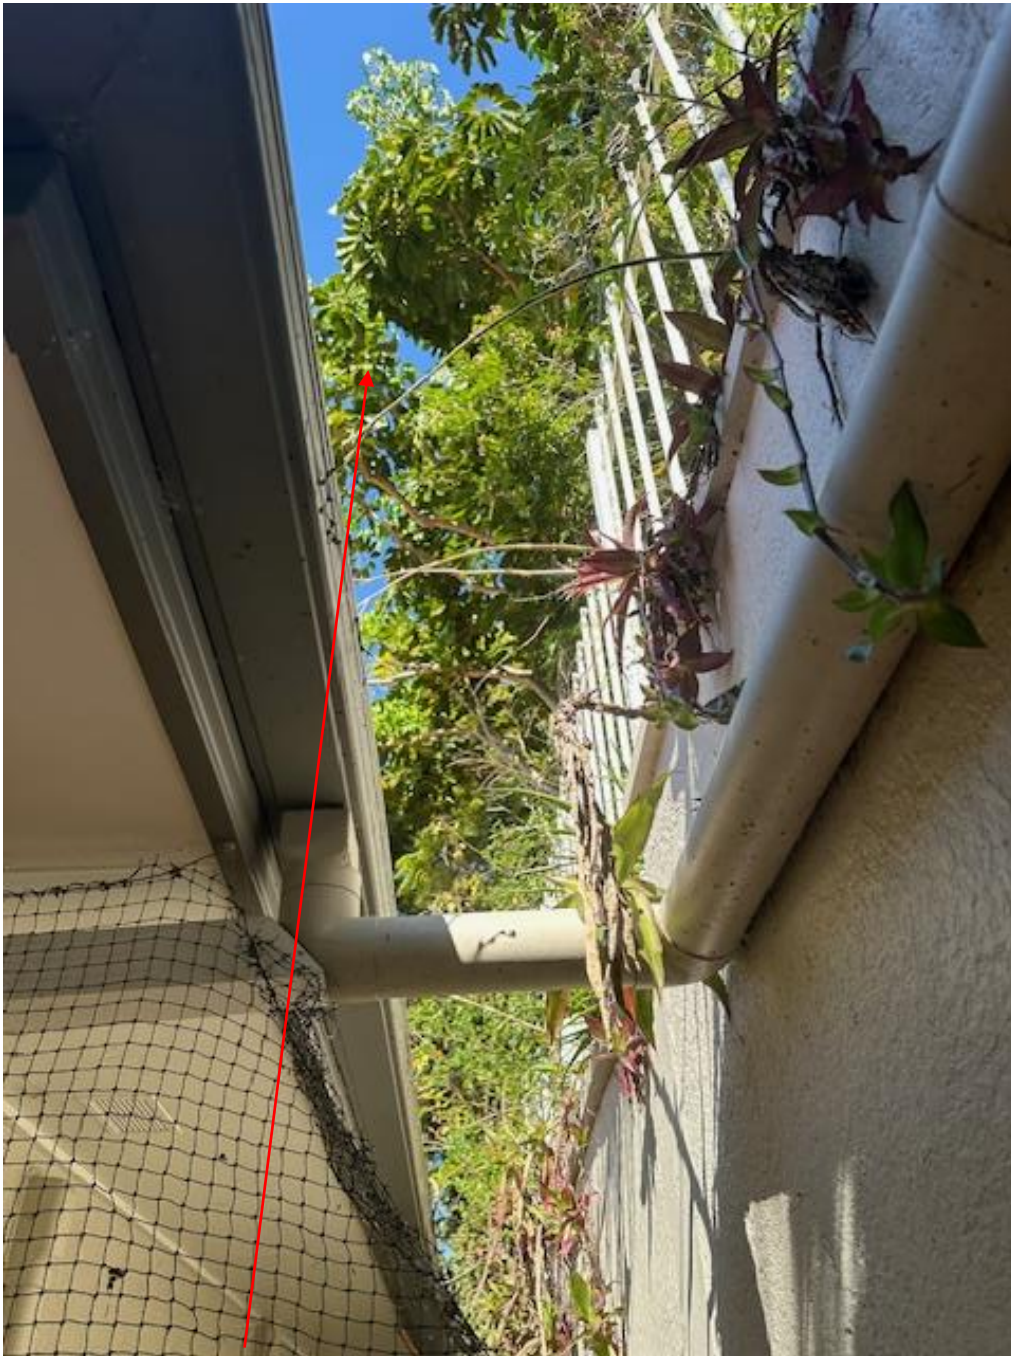
Tree No. 2 as seen from applicants

The subject tree extends across the boundary by approximately 2.5 metres.

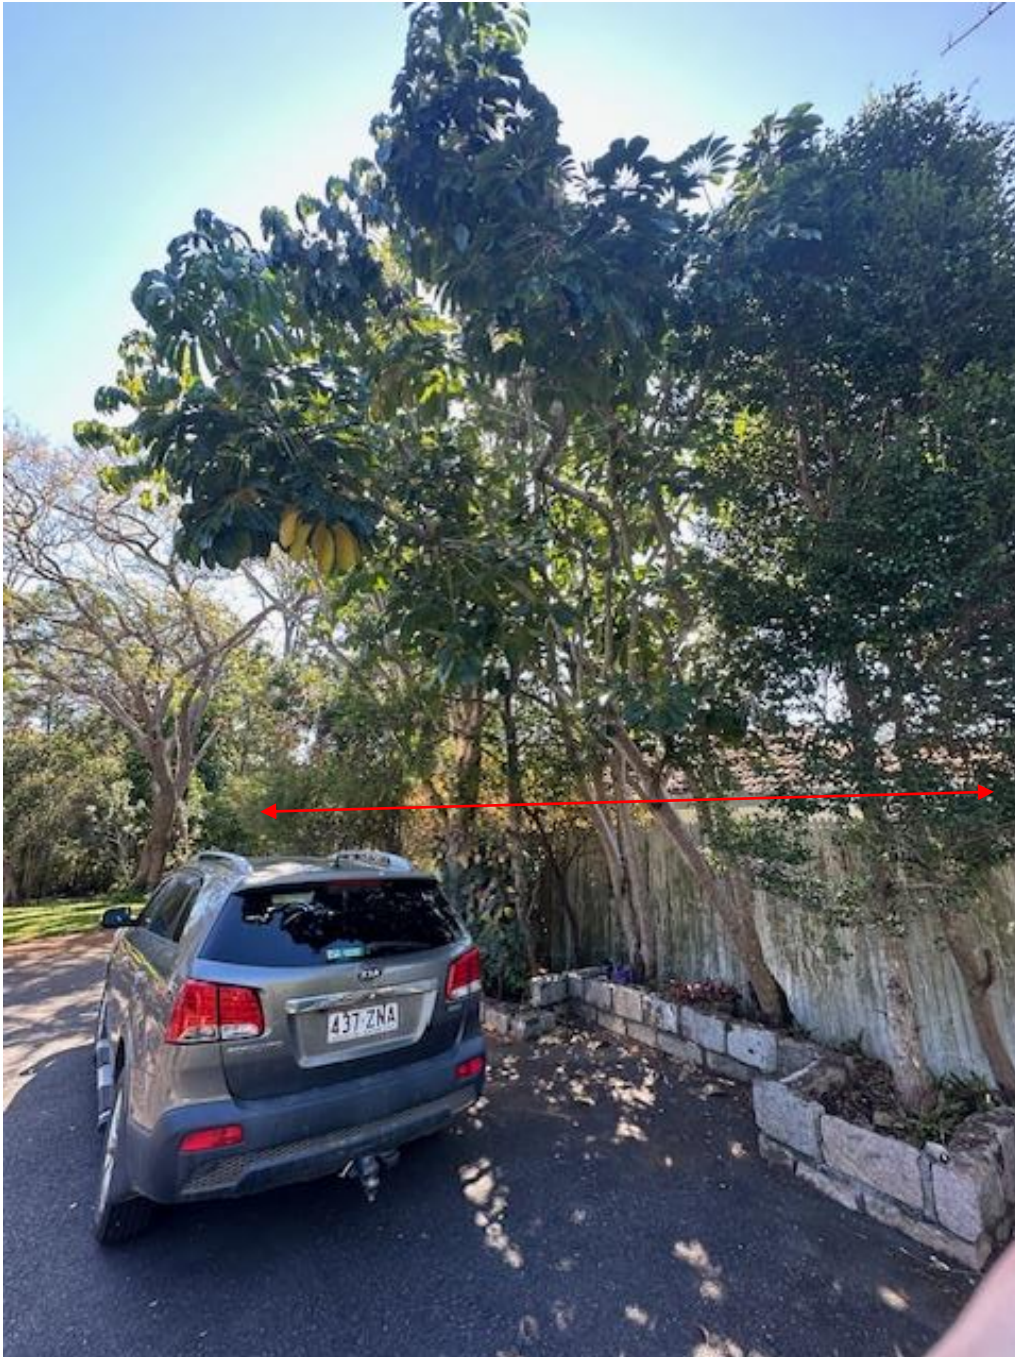
They encroach upon the applicant's property at various distances between 1 and 2 metres along the entire dividing fence.

Boundary plantings in proximity to dividing fence

It is recommended that all small trees and shrubs (Tree No. 3) be pruned back to the dividing fence once yearly as a maintenance procedure.

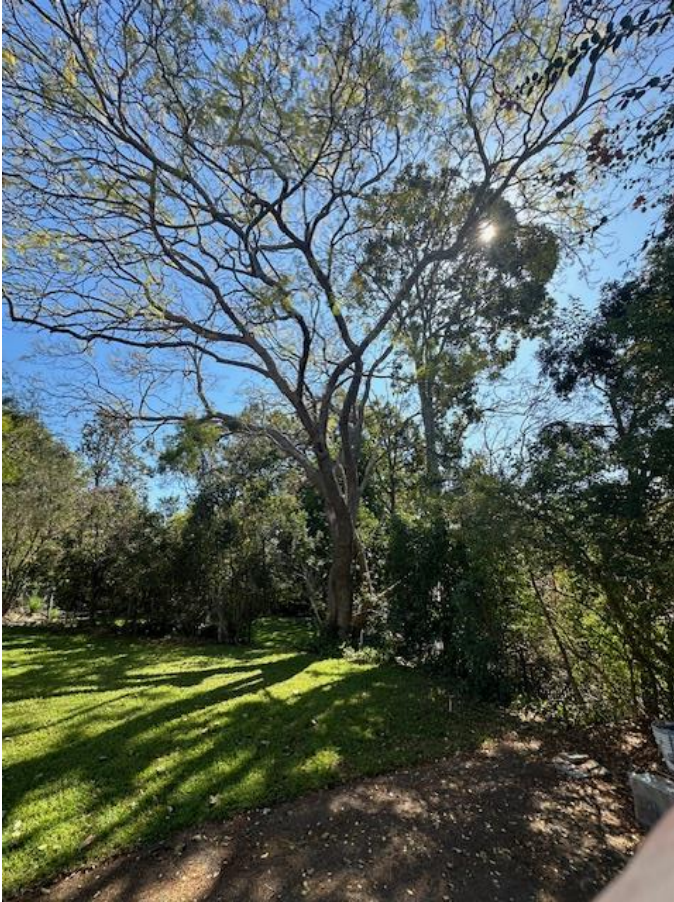
Tree No. 4 is a mature Jacaranda. The subject tree is wholly located within the respondent's property and is positioned approximately 4 metres from the dividing fence.

It is recommended that the lower limb of Tree No. 4 be target pruned back to collar.

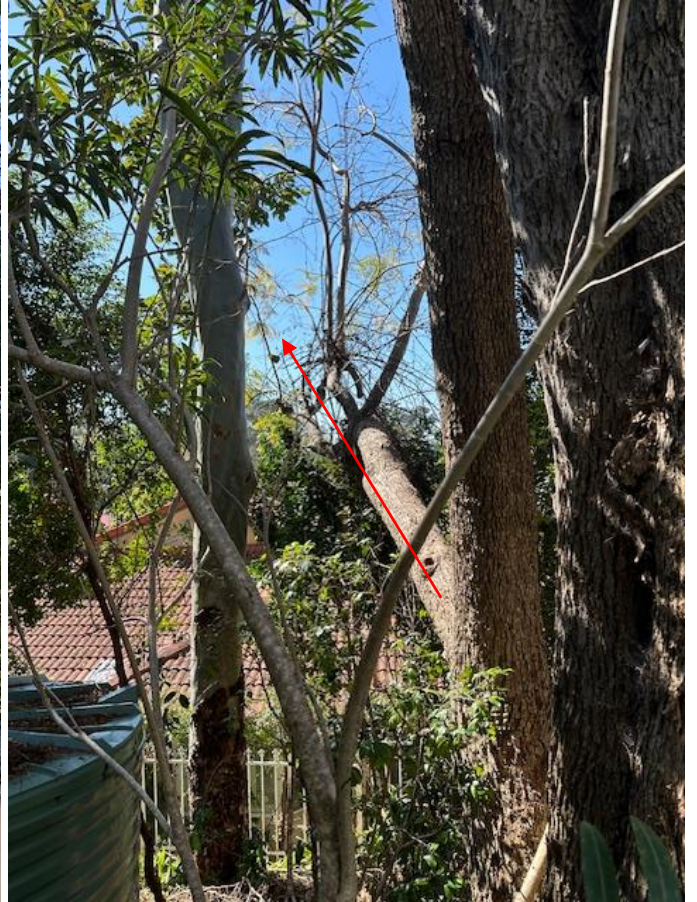
One low limb on the eastern side of the tree extends beyond the dividing fence by approximately 3.5 metres.

Extended lower limb

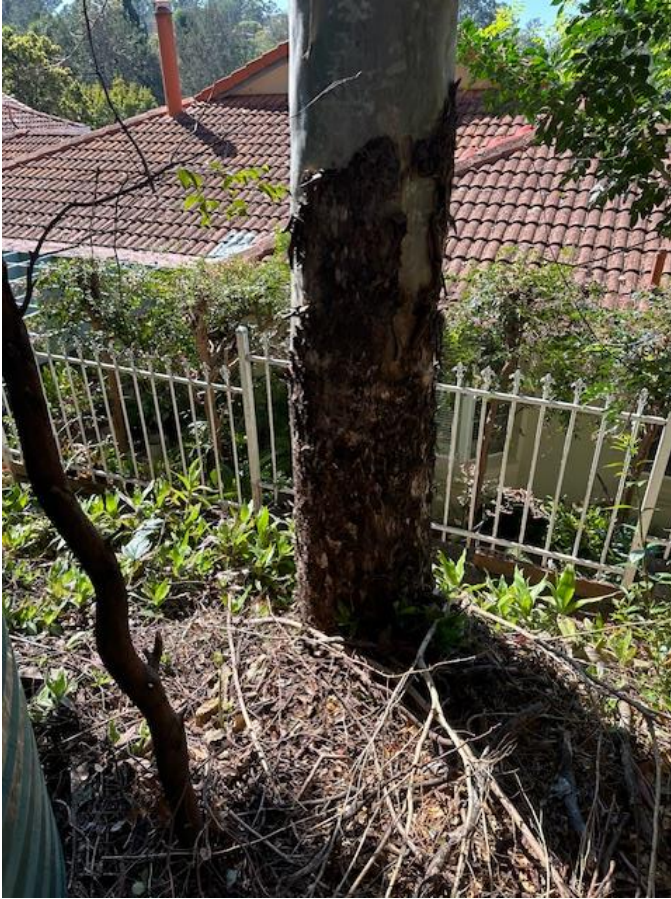
Tree No. 5 basal region

Tree No. 5 is a mature Cadaghi. It is wholly located within the respondent's property and positioned approximately 1.2 metres from the dividing fence.

It is recommended that Tree No.5 be target and directionally pruned back to the dividing fence.

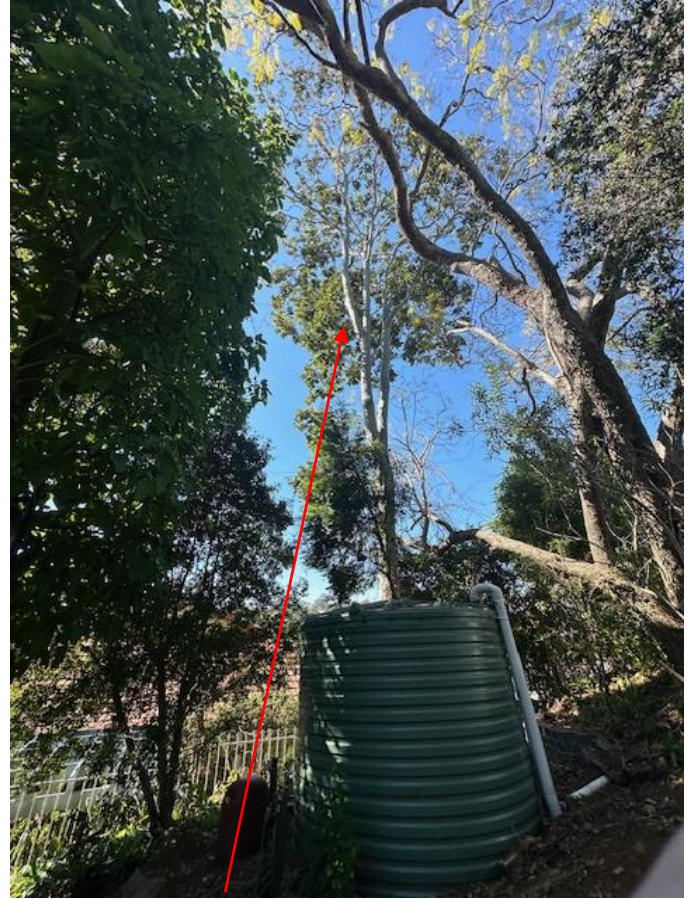
Tree No. 5 as seen from respondents

Branches in the crown of the subject tree extend across the dividing fence by approximately 3 metres.

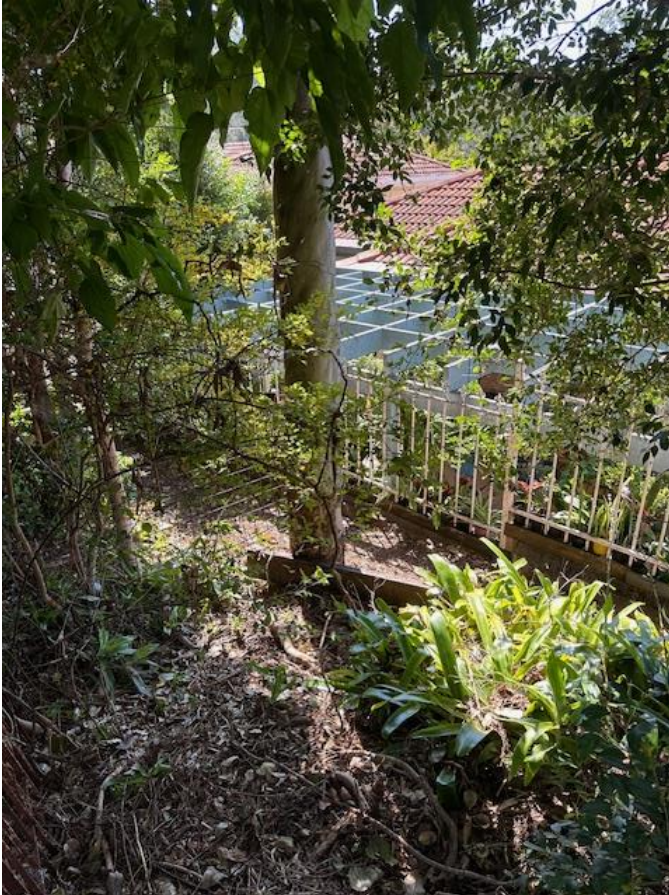
Tree No. 6 basal region

Tree No. 6 is a mature Cadaghi. It is wholly located within the respondent's property. And is positioned approximately 1 metre from the dividing fence.

It is recommended that Tree No. 6 be removed in its entirety due to crown decline and proximity to dividing fence.

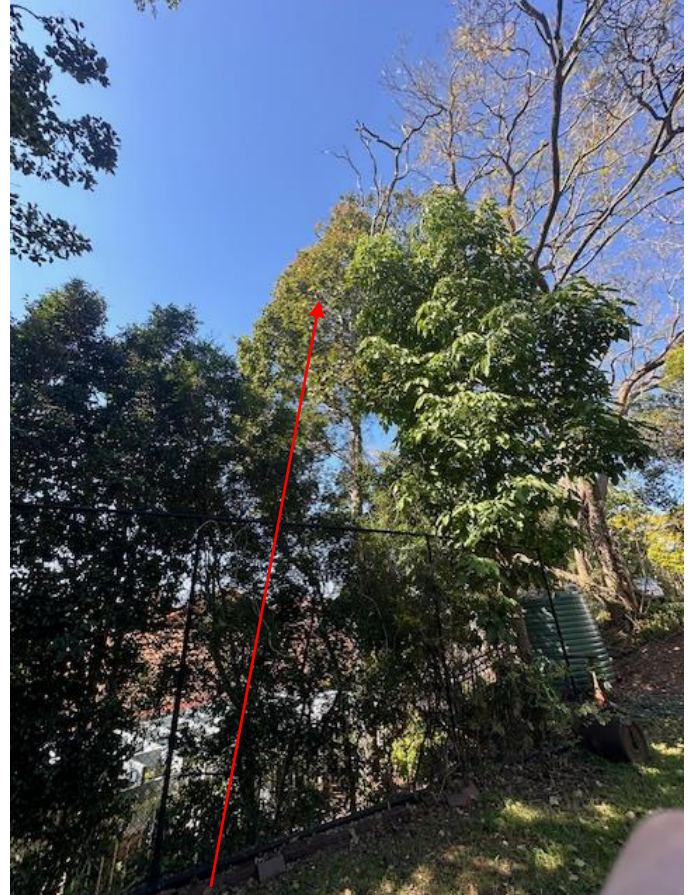
Tree No. 6 as seen from respondents

The subject shows decline with dieback in the upper crown and dead wood throughout.

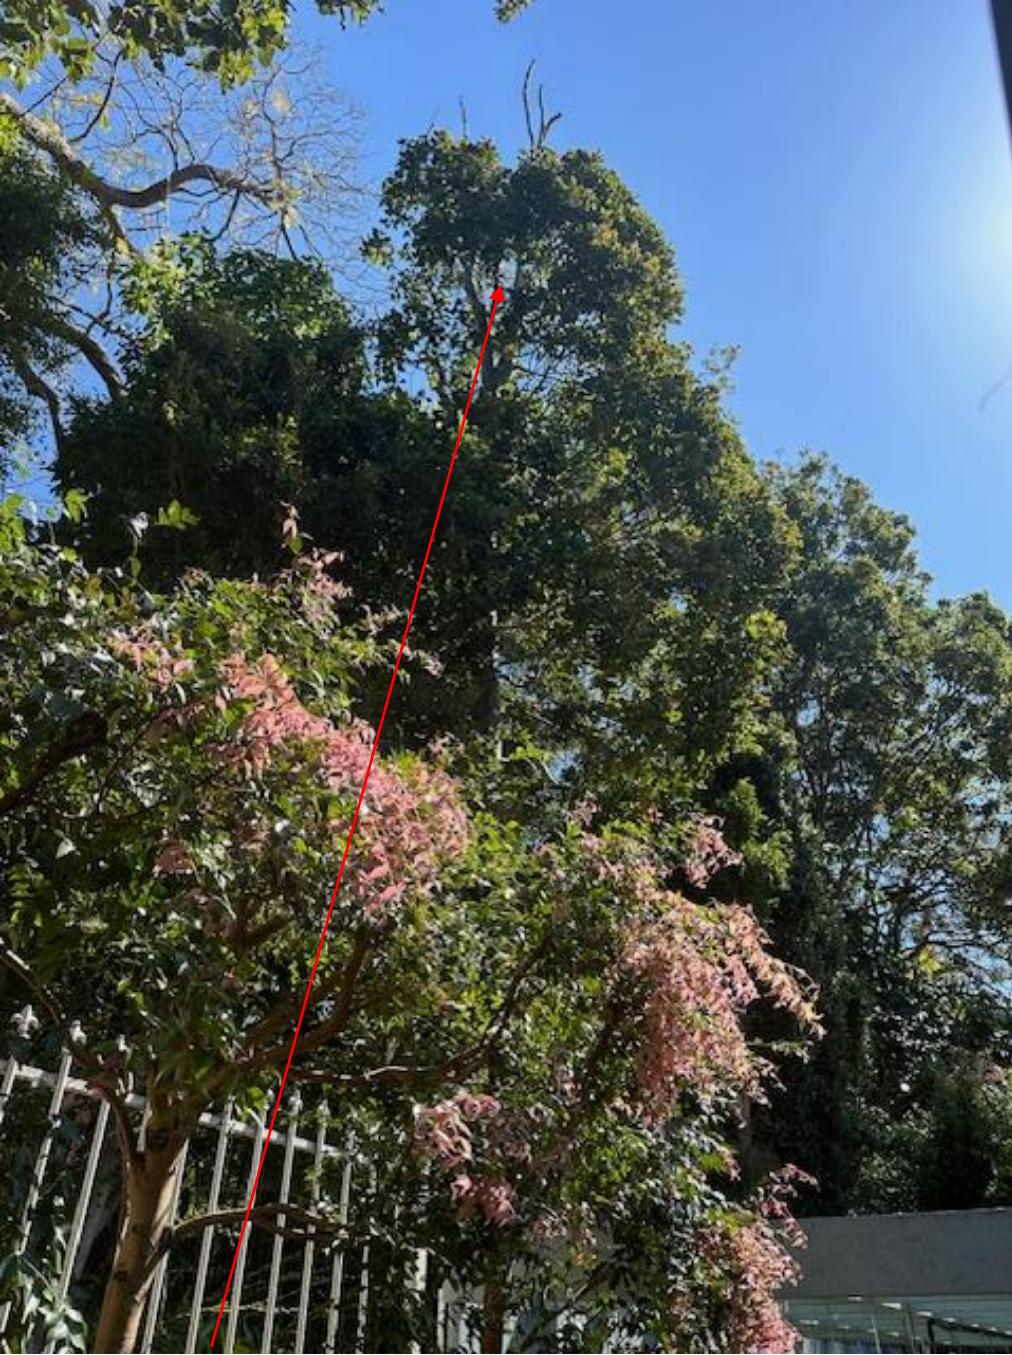
Tree No. 6 as seen from applicants

The subject tree overhangs the dividing fence by approximately 1 metre.

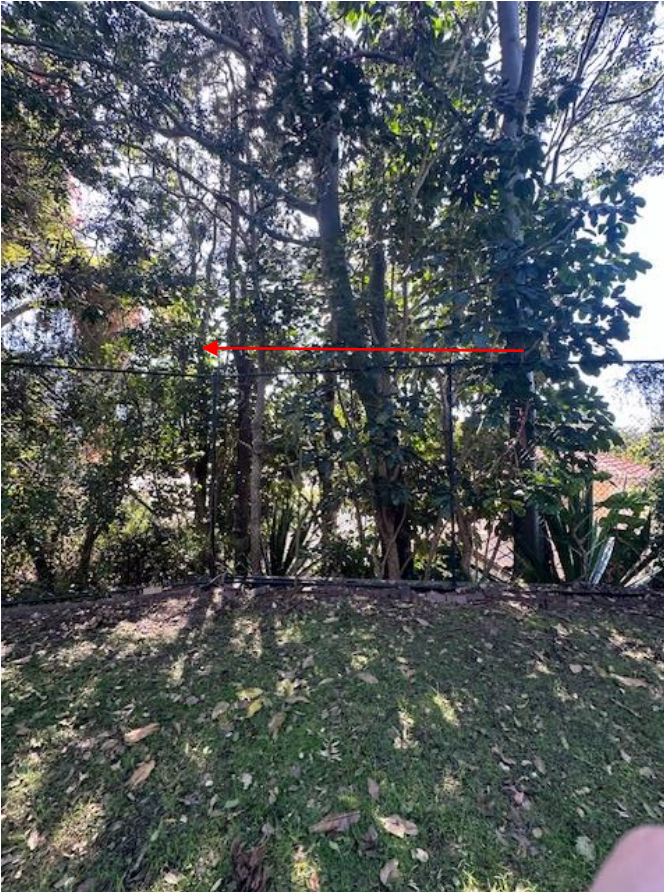
Trees No. 7-10 from respondents

Branches from the subject trees encroach across the dividing fence from between 1 and 3 metres.

Tree No. 9 is the smallest of the four trees and is suppressed growing phototropically to the east across the dividing fence.

It is recommended that Tree No. 9 be removed in its entirety due to a lack of options to effectively mitigate by pruning.

It is recommended that Trees No. 7, 8 and 10 be target and directionally pruned back to the dividing fence.

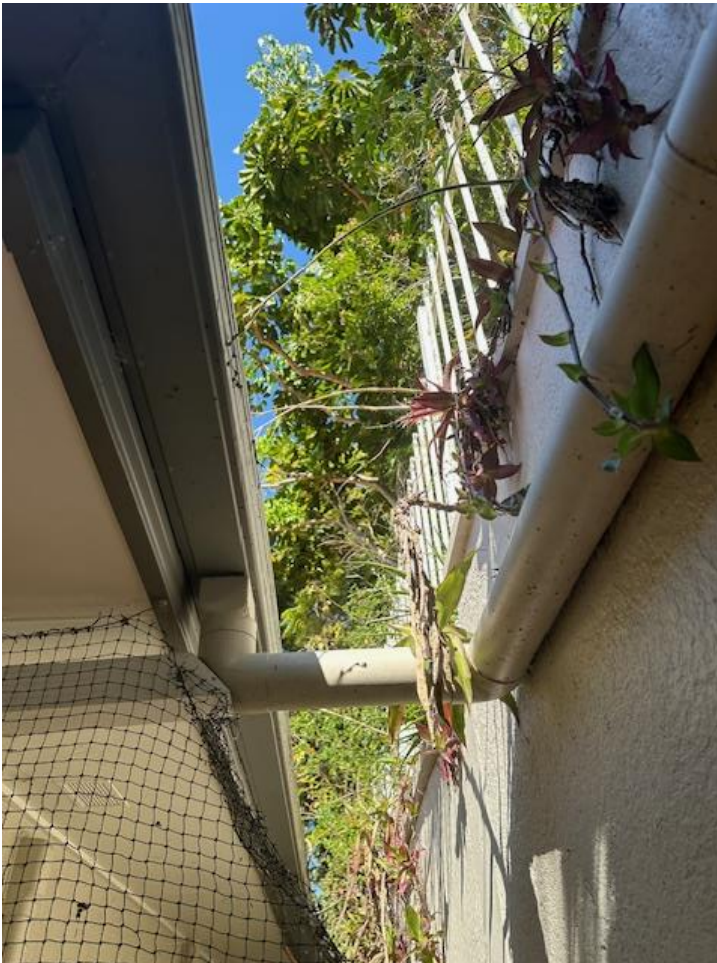
The construction of St. James Estate used a cut method to level the blocks against the dividing fence. The disparity between the natural grade of the respondent's property and the applicants below is approximately 4m. This grade change alone with the positioning of the dwellings creates a situation for limited light.

The following photograph of the rear of Lot 8, shows the proximity of the eaves to the retaining wall. This area would receive very little sunlight even if all vegetation was removed.
